Mystery of the Separating Tungsten Carbide Burs

K C Lim

Abstract — Three instances of tungsten carbide bur separation, one of which resulted in the patient swallowing the separated bur head are described. This spate of bur heads separating from the shank was associated with a cold sterilising solution used for disinfection.

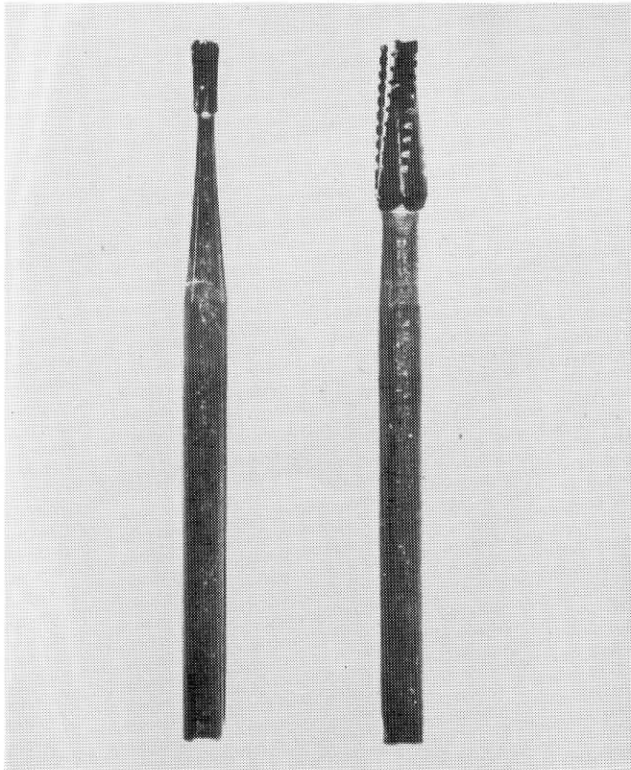
During routine cavity preparation for a Class III composite restoration, the head of Jet carbide bur #330 (Beaver Dental Products, Canada) (Fig. 1) separated from the shank. The separated bur head was retrieved from the cavity and a new bur was used to complete the cavity preparation without further incident.

Fig. 1 — Jet Carbide bur # 330 (left) and #720 (right).

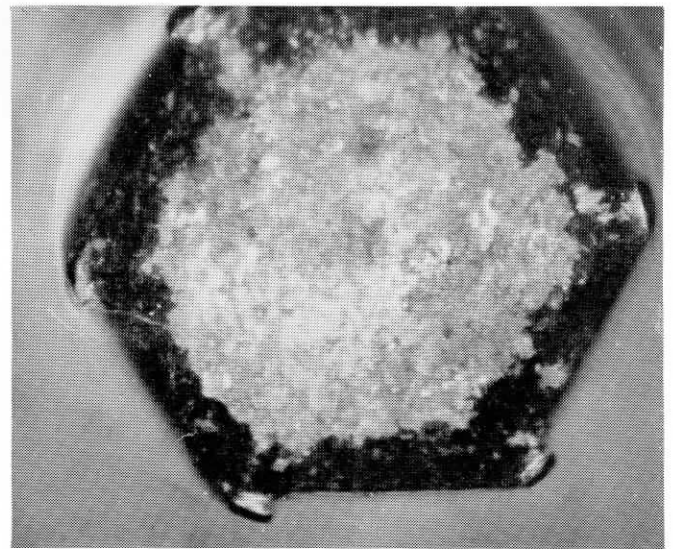
The next day, a large Class II amalgam restoration was to be placed. On contacting the tooth, the bur head of a Jet carbide Bur #702 (Fig. 2) separated immediately from its shank and got lodged in the patient's throat. The chair was put upright from the supine position and the patient tried to cough out the bur head, however, he could not and instead swallowed it. A new bur was subsequently used and the restoration completed without further incident.

Fig. 2 — Photomicrograph of the separated end of the JET carbide bur #702 showing a peripheral zone of corrosion.

4. Defective batch of tungsten carbide burs. The author has used Jet carbide burs previously and had not experienced bur separation before. This could possibly be a defective batch therefore the shank of the Jet carbide bur #702 from Case 3 which was retained, was sent to its manufacturer for investigation. The photomicrograph of the separated bur shank (Fig. 2) showed evidence that the bur was immersed in or subject to a solution that leached into the weld joint between the carbide bur head and steelplate of the bur shank. This reduced the weld area to cause separation of the bur.

It is likely that the main cause of bur separation was weakening of the weld point between the tungsten carbide bur head and the steel shank by corrosion as a result of immersion in Sporicidin cold sterilising solution. Prior to these three instances of bur separation, the burs were not disinfected by immersion in Sporicidin cold sterilising solution. The manufacturer's instructions state that Sporicidin "should not be used as an overnight holding solution for carbon steel and dental burs". In the light of the cause of the corrosion of the tungsten carbide bur weld joint, the dental assistant affirmed that the burs were removed after 10 minutes immersion in Sporicidin, rinsed in sterile water then dried. Each set of burs were immersed probably on two or three occasions only before this practice was discontinued. Even providing for 5 minutes extra per immersion, the burs were

The Jet carbide #330 bur is 0.8 mm in diameter while the Jet carbide bur #702 is 1.6 mm in diameter. Weakening of the weld joint by corrosion will affect the narrower weld point of the smaller #330 bur before the larger #702 bur, therefore in these three cases, the #330 burs separated before the #702 bur.

Like most cold sterilising solutions which are effective against Hepatitis and AIDs, Sporicidin is based on a glutaraldehyde solution. Glutaraldehyde is effective against all micro-organisms, including viruses and spores,² however, it can corrode some metals. Therefore, it will be prudent to avoid cold sterilisation of tungsten carbide burs in glutaraldehyde solutions unless there is good evidence that the weld joint will not be affected. Further studies need to be performed to ascertain if other brands of tungsten carbide burs are similarly affected by Sporicidin, or if other cold sterilising solutions affect the strength of the weld joint of tungsten carbide burs. Some cold sterilising solutions contain anti-rust additives, presumably these will be safer to use.
