Methods of Proximal Amalgam Overhang Removal — A Comparison of Different Techniques

K C Lim,* *AM, BDS, MSc*, G H L Ong,** *AM, BDS, MSc*

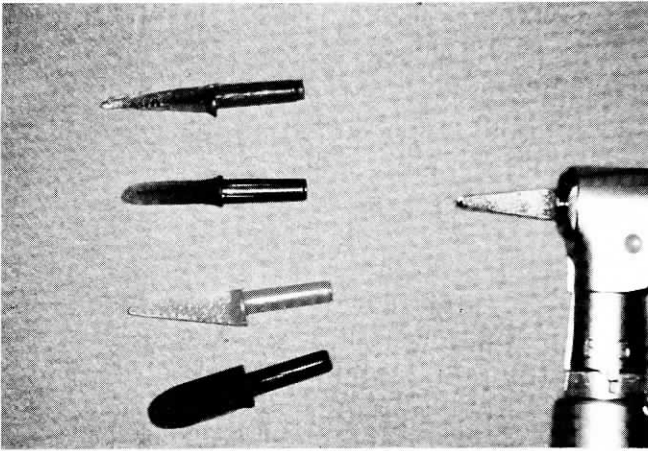
Fig. 1. EVA reciprocating handpiece with diamond tip (right) with assortment of plastic tips (left) for carrying prophylaxis paste to polish the trimmed proximal surface.

1. EVA reciprocating motor-driven diamond tips (Fig. 1) (Ka Vo, EWL VmbH, Postfach, West Germany).
2. EVA reciprocating motor-driven diamond tips followed by the plastic tips located with prophylaxis paste (Nupro, Johnson & Johnson, New Brunswick, USA).
3. Roto-pro bur (Hager & Meisinger GmbH, Dusseldorf, Federal Republic of Germany) fitted into an air-rotor handpiece (Fig. 2).
4. Flame-shaped steel finishing bur (Ash Instruments, Gloucester, England) in a conventional handpiece.
5. Diamond bur (Hi-Di ISO #197/014, Ash Instruments, Gloucester, England) in an air-rotor handpiece.

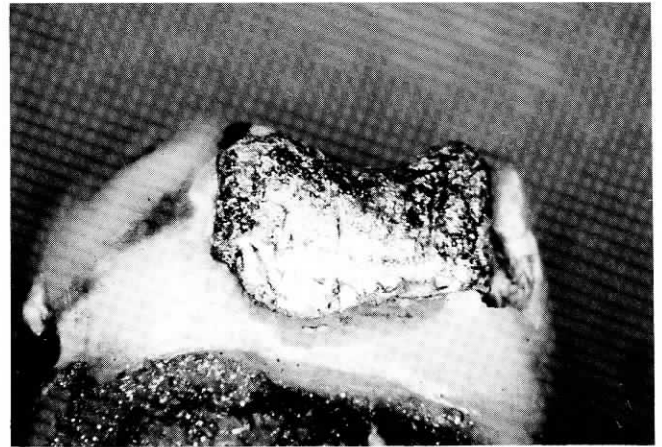
Fig. 3. Overhang removal with the sonic scaler produces a very rough surface. The adjacent tooth surface however, is not usually damaged by the sonic scaler.

The sonic scaler produced the roughest surface. Unlike the other methods which cut the excess amalgam, the

sonic scaler works by using vibration to break off the overhang at its narrowest and consequently weakest portion, which is usually at the cavity margin. This uncontrolled fracture of the overhang could also result in the reverse situation, a deficit.

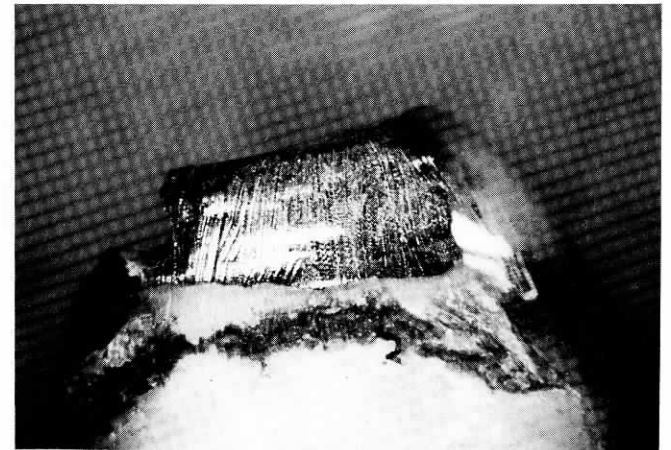
Fig. 4. The surface shows the vertical grooves in the amalgam surface caused by the rotating diamond surface.

The standard diamond bur produced the roughest surface, but diamond burs come in a variety of diamond grit sizes and also very narrow tip designs so that where the interproximal space is narrow and inaccessible to other instruments, there will probably be a diamond bur which could get in to do the job. The flame shaped steel bur gives a reasonable surface, although being fitted to a conventional motor, will take longer to remove the overhang than the other methods driven in a air-motor handpiece.

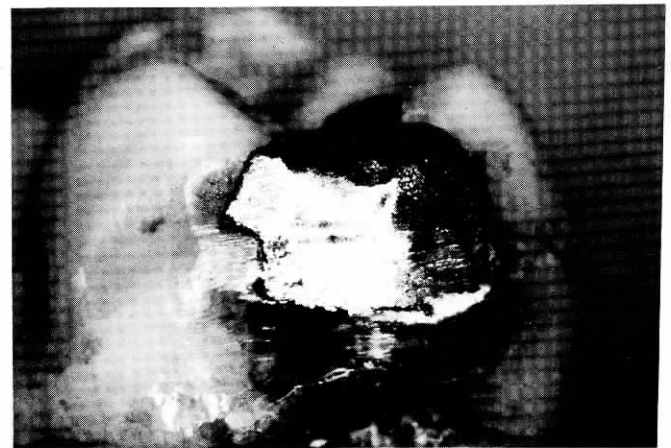
Fig. 5. The surface produced by the EVA fitted with the diamond coated tip is essentially similar to that produced by a diamond bur except the reciprocating action of the handpiece produces horizontal grooves on the trimmed amalgam surface. There is also some damage to tooth structure. Removal of the overhang revealed lining cement which extended right to the cavity margin (arrow).

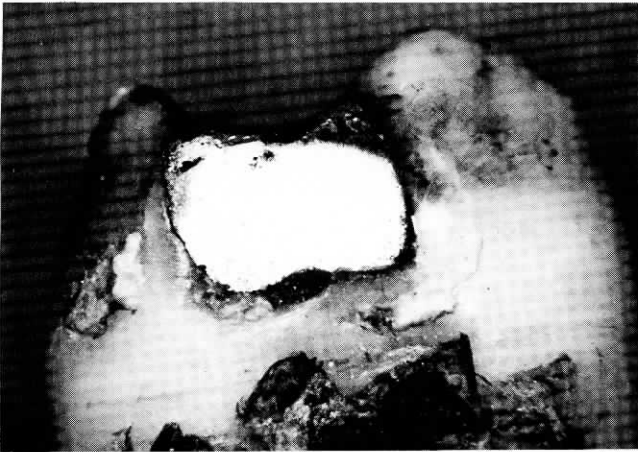
Fig. 6. After overhang removal with the EVA diamond-tip, the surface was polished with prophylaxis paste placed onto the plastic tip. This produced a relatively smooth surface. Under the overhang as recurrent caries.

The overhanging amalgam restoration would enhance accumulation of dental plaque below the ledge caused by the overhang, resulting in caries (Figs. 6 & 7) and periodontal disease. Further, plaque also accumulates on the surface of the restoration itself. Hence the objective of overhang removal should be to remove the overhang and leave a surface that is sufficiently smooth to allow efficient plaque removal by the patient.

The smoothest surface after overhang removal is undoubtedly produced by the EVA system where the diamond tip trimmed surface is polished with prophylaxis paste using the plastic tip of the EVA system. However,

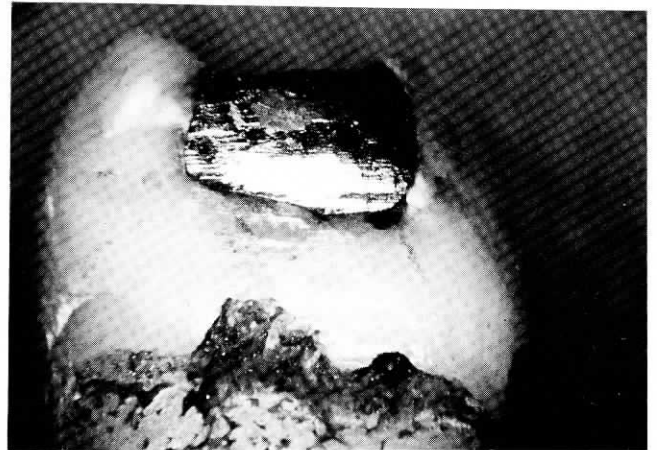
Fig. 7. The flame-shaped steel finishing bur produces horizontal grooves on the trimmed surface. This tooth had recurrent caries at the two line angles of the proximal box. There is slight damage to the tooth below the overhang.

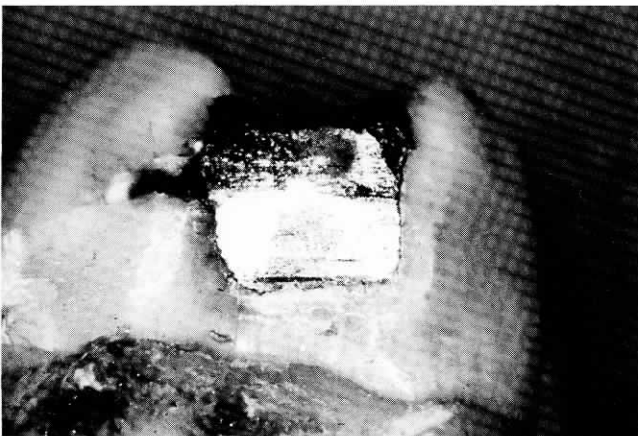
Fig 8. The roto-pro also produces horizontal grooves on the trimmed amalgam surface. There is damage to adjacent tooth structure.

The roto-pro, was actually designed to fit into the air-rotor handpiece to remove calculus. It removed the overhang quickly and produced a reasonably 'smooth' surface. Its narrow tip also makes it accessible to all but the narrowest of interproximal areas.

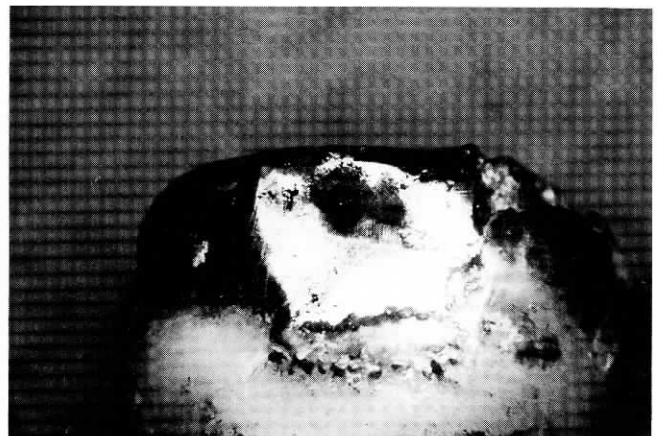
Fig. 9. The surface was produced by polishing with brownie and greenie points. The polished amalgam surface makes the voids and poorly adapted margins of the amalgam obvious.

A feature in all groups, although not in all teeth, were the defective margins, such as voids and gaps which were often associated with proximal amalgam overhangs. These defects were also observed in other studies.⁴⁻⁵ The gaps and voids are probably the result of incorrect choice or placement of the matrix band and/or absence or incorrect placement of the interproximal wedge, which could also result in insufficient condensation pressure. Besides these defects in the marginal adaptation and quality of the proximal amalgam restoration, in the process of removing the overhang, the surrounding tooth tissue is likely to be damaged or roughened. Further, these overhangs are often subgingival, and have to be
